Assessment Of Blind Via Holes – An Alternative Approach

by Bob Willis,
ASKbobwillis.com

While the use of blind vias has become fairly common in electronics manufacturing today, inspection of via holes during fabrication is still problematic. We take a look at a simple and easy way of assessing blind vias that makes failure analysis easier to perform and produces less controversy.

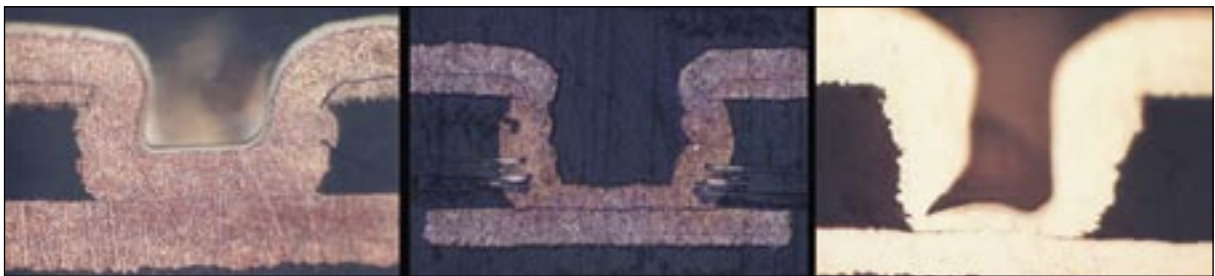
Figure 1 - Typical examples of via connections

debate on the cause of any failure or if a particular via is satisfactory or not. The images in Figure 1 show typical examples of different via connections.

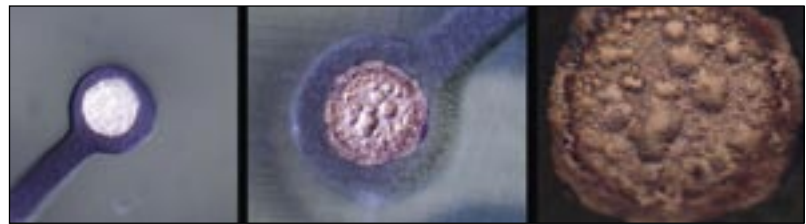
Figure 7 - Close up of a via pad after removal (left), the surface of the Copper under the via hole (middle) and a close up of the Copper surface (right)

is not reached, far less strain will be put on the track and Copper pad during peeling. When the Copper track is peeled back, the capture pad will also be separated from the base of the plated via. Figure 7 shows a close up of a via pad after removal (left), the surface of the Copper under the via hole (middle) and a close up of the Copper surface (right).

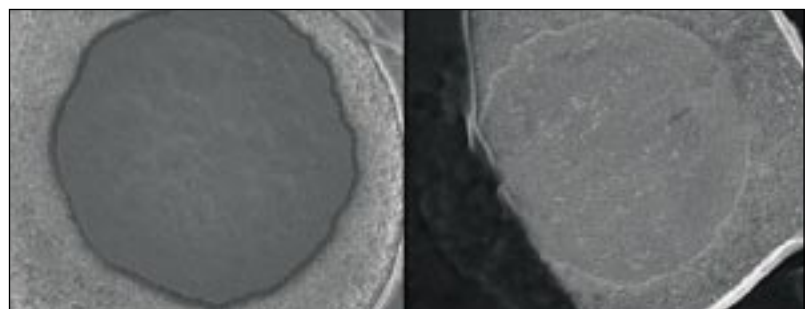
Figure 8 - The two SEM images show the surface of the 0.020" 0.5mm capture pad (left) after separation from the bottom of the 0.010" 0.25mm blind via (right). There is no evidence of a fractured surface suggesting that a true bond could not have formed during the blind via plating process. Although no measurement of the force to remove the capture pad has been made, the bond was noticeably weaker than pads of the same size on known good vias

Using an SEM, images can be taken of both mating surfaces. A mechanical break between two Copper surfaces should provide a distinctive pattern allowing comparison on both surfaces. If the vias were correctly formed with a sound metallurgical bond but failed due to assembly or rework conditions, a hard fracture would be noted.

If the quality of the plating, hole and pad surface preparation was poor, then surface analysis on an SEM should be able to identify and characterise any contamination. It could then compare with the surrounding materials used in the fabrication process.
